# Methods for coastal monitoring and erosion risk assessment: two Portuguese case studies

A. Bio <sup>@, a</sup>; L. Bastos <sup>a, b</sup>; H. Granja <sup>a, c</sup>; J.L.S. Pinho <sup>d</sup>; J.A. Gonçalves <sup>a, b</sup>; R. Henriques <sup>c, e</sup>; S. Madeira <sup>a, f</sup>; A. Magalhães <sup>a, g</sup>; D. Rodrigues <sup>d</sup>

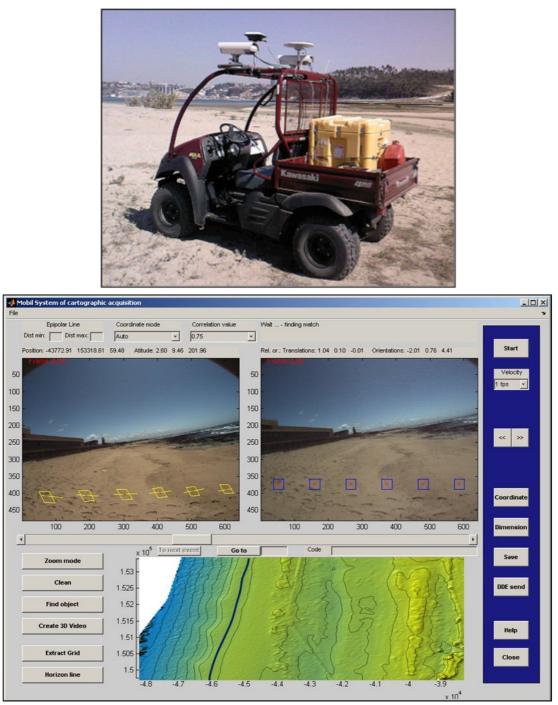
Figure 1 - Terrestrial mobile mapping survey. A: Four-wheel vehicle with two kinematic antennas and videogrammetric equipment; B: Screenshot of the software used to extract topographic coordinates and terrain features.

Traditional land surveying methods are time consuming, and therefore also expensive. A much more efficient alternative is the use of a Mobile Mapping System (MMS), using a direct georeferencing system and video cameras, which is easily and quickly put into operation under almost any weather conditions. The observing methodologies applied in our case studies, evolved with time. In the sand spit study, surveys started with an on-foot GPS equipment (used until 2002), followed by a two antenna system installed on a moto-quad (from 2003 to 2009) (Baptista et al., 2008) and, more recently (since 2009), by a videogrammetric (Fig. 1), which can be used with different direct georeferencing systems, developed at the University of Porto (Madeira, 2007; Madeira et al., 2010). In the second case study, only the two-antenna system was applied.

Measurements with the MMS were collected continuously, in kinematic mode, using GPS post-processing relative positioning. Positioning and orientation of the cameras was initially done using a GPS-only dual frequency multi-antenna setting to derive roll and later a GPS/INS georeferencing system based on a dual frequency GNSS receiver and a navigation-grade IMU (Inertial Measurement Unit), which allows determination of the vehicle orientation in all three angular directions (roll, pitch and heading). Here, we present results obtained using the latter setting.

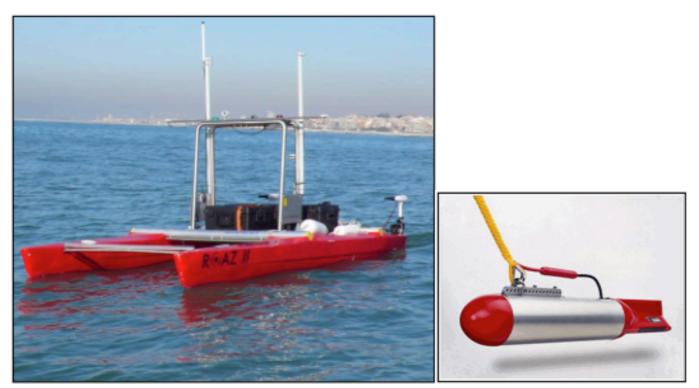
Figure 3 - Bathymetric and seabed survey. A: Autonomous catamaran, platform with GPS RTK and altimeter; B: Side-scan sonar.

An Autonomous Surface Vehicle (ASV), a remotely computer controlled, 4.2 m long catamaran (Fig. 3), was used for bathymetric surveys (Ferreira *et al.*, 2009). Vehicle navigation and positioning was done with a PolaRx RTK GPS, with a horizontal accuracy of 2 cm and a vertical accuracy of 4 cm. The platform was furthermore equipped with a Tritech digital single beam side-scan altimeter sonar; a 500 KHz echo-sounder with 60 conical beam width and 1 cm of range resolution, measuring bathymetry and capturing acoustic images of the ocean bottom. The ASV was electrically propelled and the sonar sensor heads mounted at the aft of the boat without interference from the hull motion and propeller induced noise.
